Our Ref: APPBMSMA-2017-02 Special Functions Group

BUILDING OWNERS TO REGULARLY INSPECT AND MAINTAIN BUILDINGS' EXTERIOR FEATURES

Aim

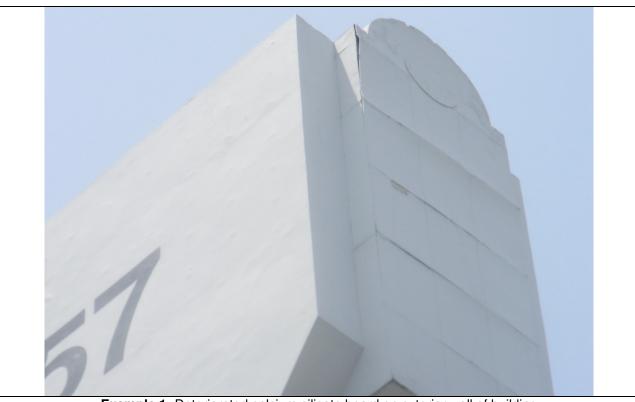
Example 1: Deteriorated calcium silicate board on exterior wall of building

- 4. As these boards are subject to external weathering, Building Owners are reminded to carry out regular and thorough inspections and maintenance of such boards to ensure that they remain securely fastened to the building. Where there are signs of deterioration (e.g. warping, looseness, etc.), these boards should be removed or replaced with a more appropriate material.

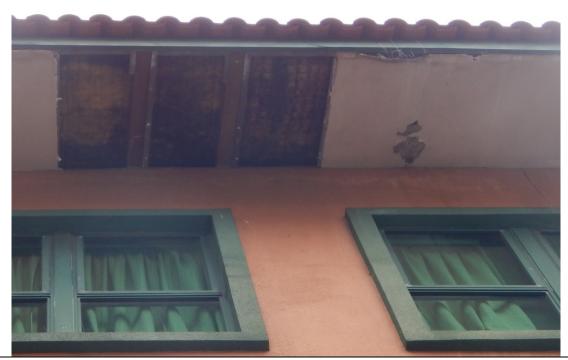
Example 2: Deteriorated gypsum board used as ceiling panels underneath of roof eave of building
